Standard Practice for Roads and Parking Lots Pavement Condition Index Surveys¹

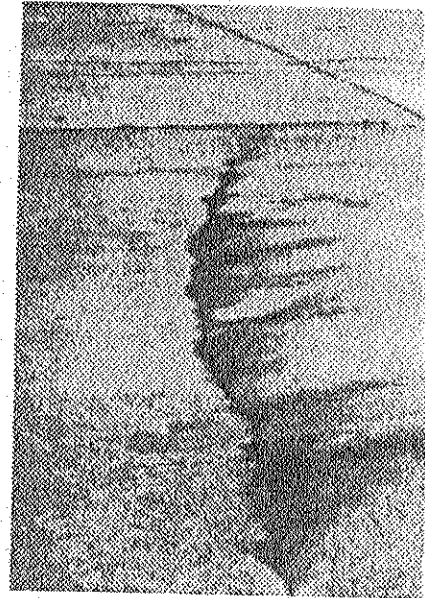
* X2.15.1 *Severity Levels*—No degrees of severity are defined. It is enough to indicate that pumping exists (Fig. X2.33 and Fig. X2.34).

X2.15.2 *How to Count*—One pumping joint between two slabs is counted as two slabs; however, if the remaining joints around the slab are also pumping, one slab is added per additional pumping joint.

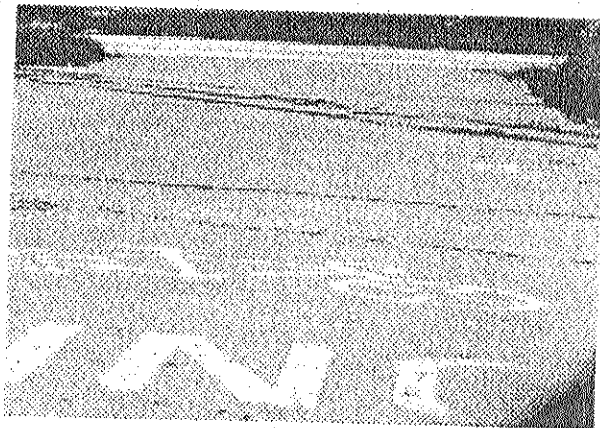
FIG. X2.39 Medium-Severity Railroad Crossing

X2.17.1.2 M—Railroad crossing causes medium-severity ride quality (Fig. X2.39).
